**Flood Control Project Maintenance
Levee Inspections****LMA District Cover Sheet****Spring 2011 Levee Inspection Results****Reclamation District No. 0524 Middle Roberts Island**

Levee Inspection Report By Mile - Spring 2011

Reclamation District No. 0524 Middle Roberts Island

| Waterway | | | | | | Bank | Unit Miles | Inspection Start/End | Inspector | |
|---|---|---|---|---|---|---|--|---|---|---|
| Unit No. 01 San Joaquin River | | | | | | Left | 6.26 | 04/06/2011 04/12/2011 | Richard Willoughby | |

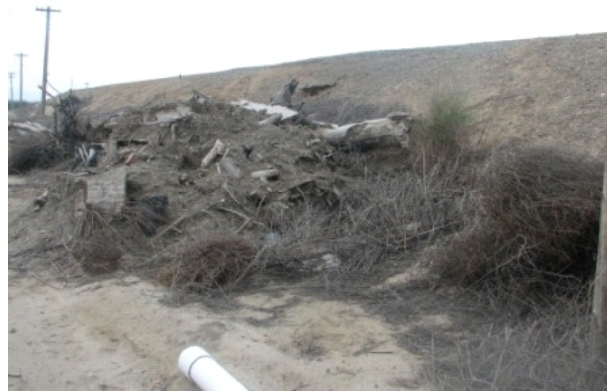
richard_s_20110215_154.jpg

Garbage pile at landward toe at LM 0.36

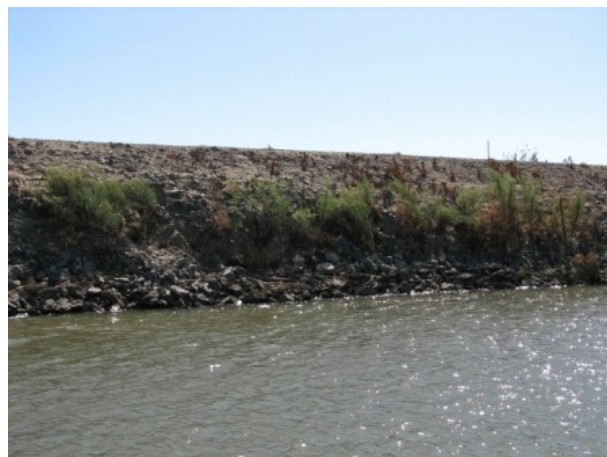
richard_s_20110215_130.jpg

Direct view of site.

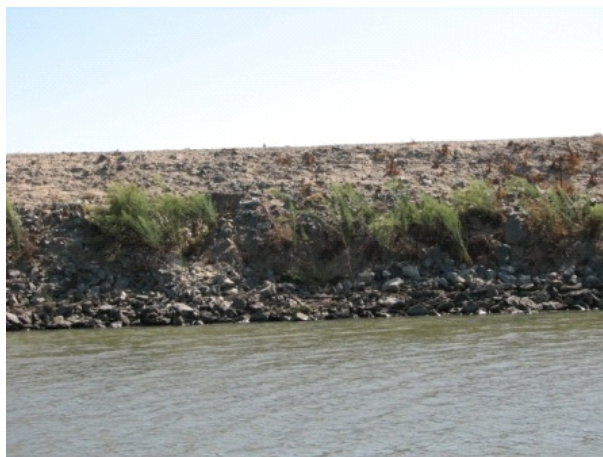
richard_s_20110215_132.jpg

Direct view of site showing emergent vegetation growing at the midslope.

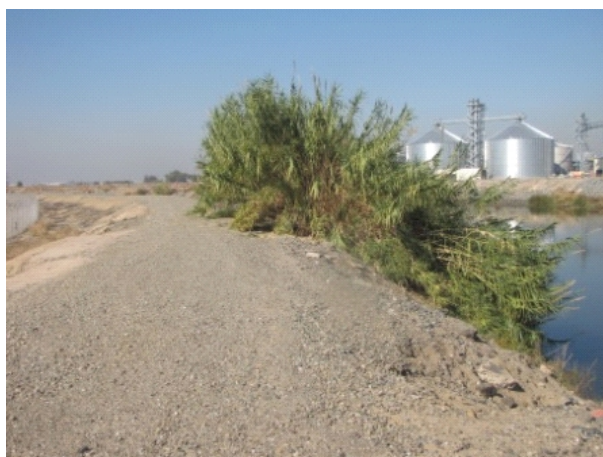
richard_s_20110215_146.jpg

Looking north at bamboo on waterside slope.

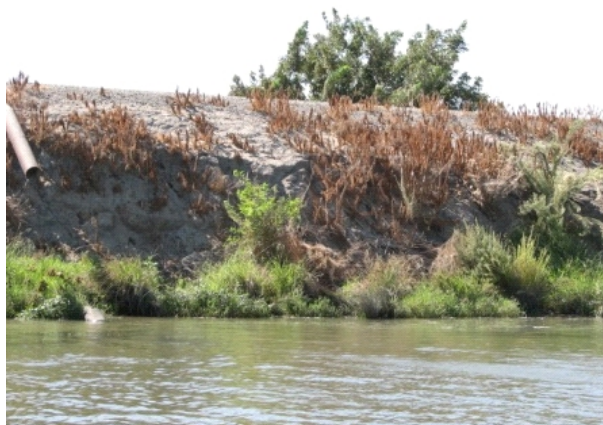
richard_s_20110215_134.jpg

Downstream view of site.

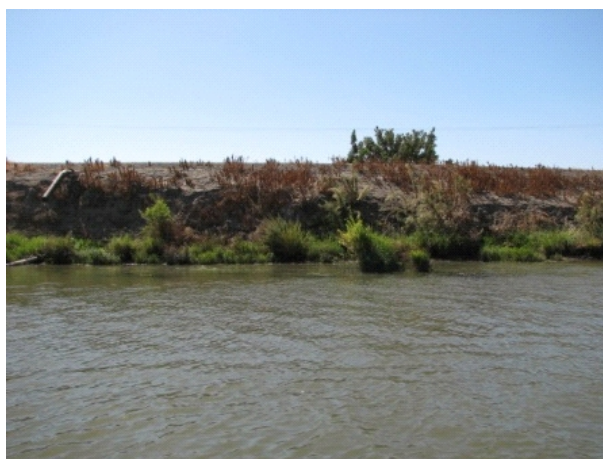
richard_s_20110215_135.jpg

Downstream view of site.

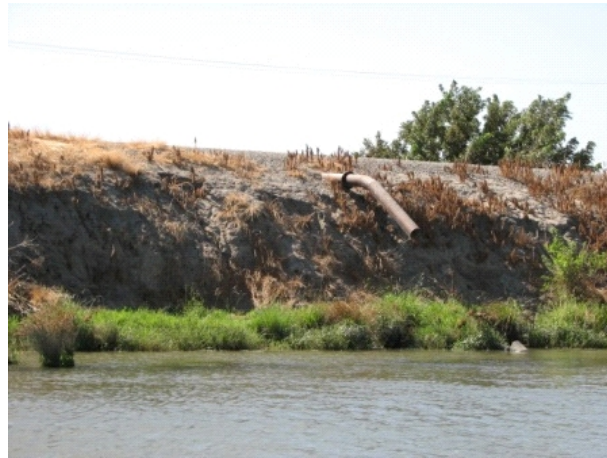
richard_s_20110215_136.jpg

Downstream view of site.

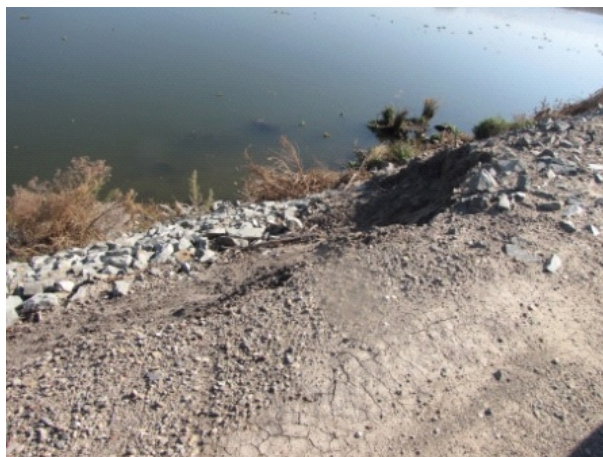
richard_s_20110215_163.jpg

Looking at erosion from top of levee

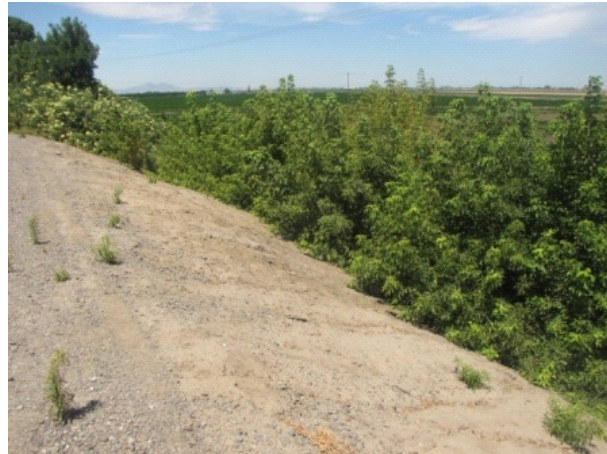
richard_s_20110215_177.jpg

Looking southwest at trees along levee landside toe.

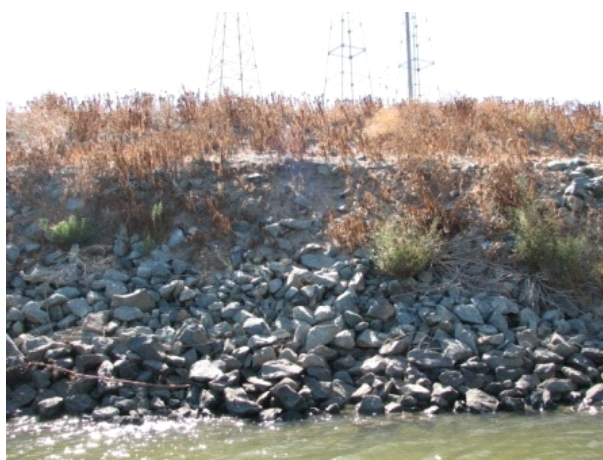
richard_s_20110215_202.jpg

Front view of sloughing rip rap.

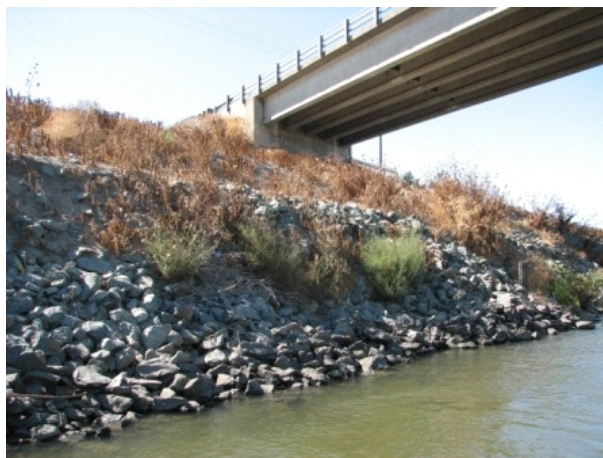
richard_s_20110215_203.jpg

Downstream view of the site.

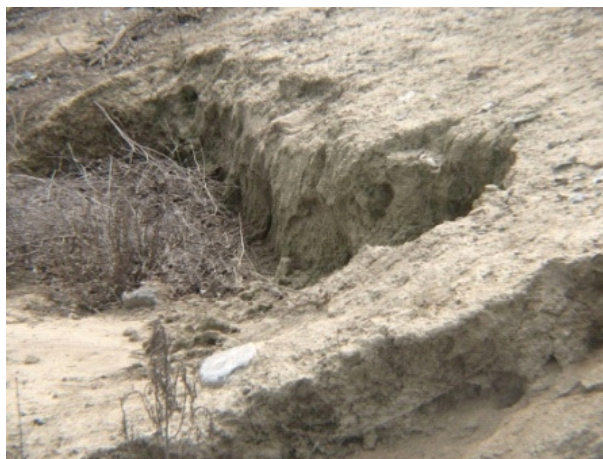
richard_s_20110215_192.jpg

Erosion at waterward toe and around irrigation pipe at LM 5.92

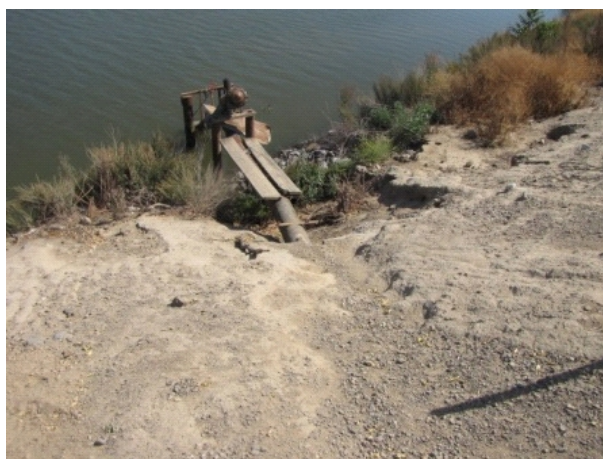
richard_s_20110215_193.jpg

Looking southeast at erosion around pipe.

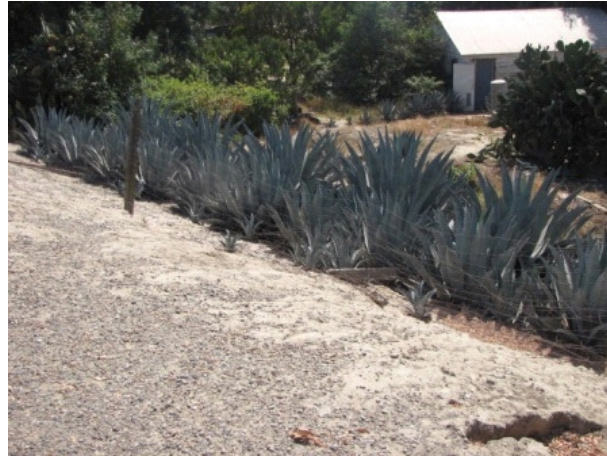
richard_s_20110215_198.jpg

Looking southeast at fence and cactus on landside slope and toe.

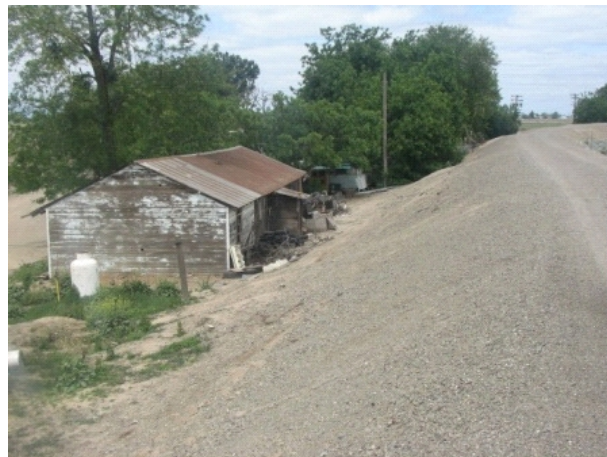
richard_s_20110215_199.jpg

Looking downstream at building on landside toe.
